THE IDENTIFICATION AND  
CONSERVATION OF THE INTERIOR  
ARCHITECTURAL PLASTICS  
AT DRAGON ROCK

Christeen Yoriko Taniguchi

A THESIS

Historic Preservation

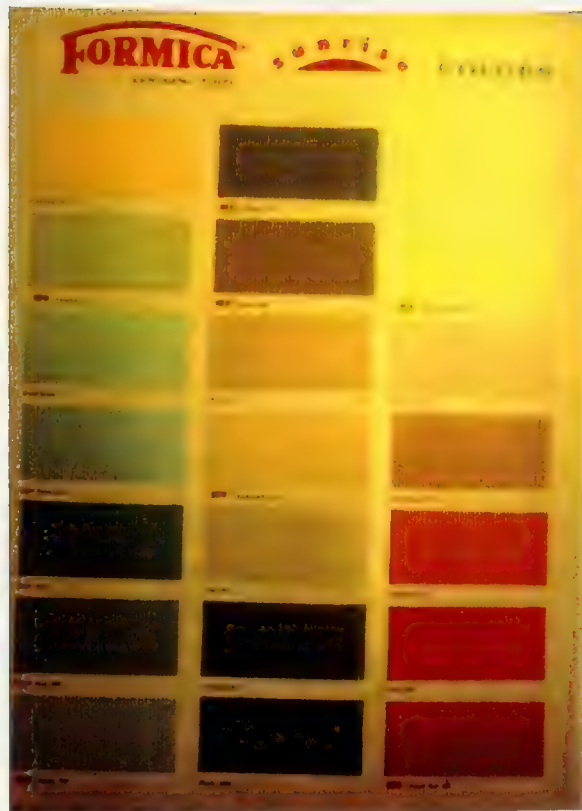
5-15

“1950s Formica® sample card. Note the ‘light aqua’ that was used for the original harem bathroom counter, fourth down in the first column.”

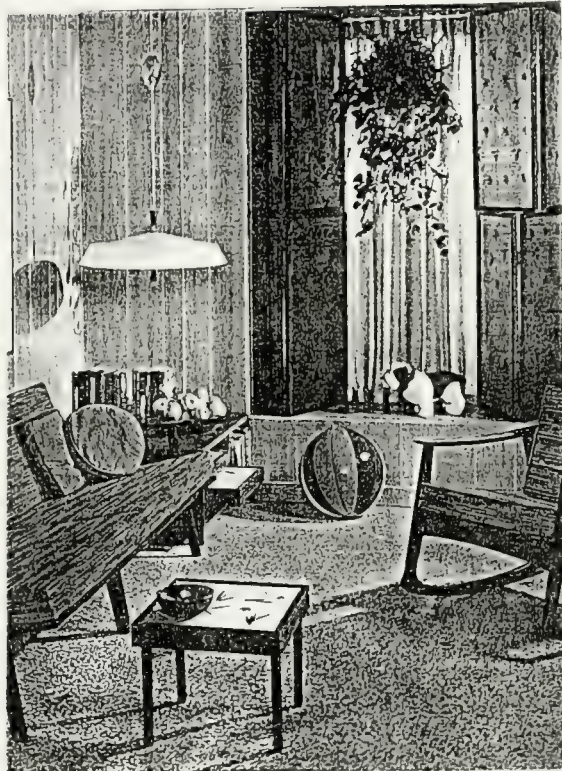
5-17

“‘Play-as-You-Grow Living Room’ in *Good Housekeeping* from 1960. Note the window panels which are similar in pattern to the harem toilet/bathroom hall sliding door.”

Interestingly, some contemporary and later articles and trade catalogs presented designs similar or identical to some of the components in the house. An example of this is the sliding door between the harem bedroom hall and the bathroom hall, which was found in a an issue of *Good Housekeeping* from 1960. As often happens, it is likely that Wright's designs were picked up by manufacturers for the mass market, without giving credit to the original designer. This issue needs to be further studied.

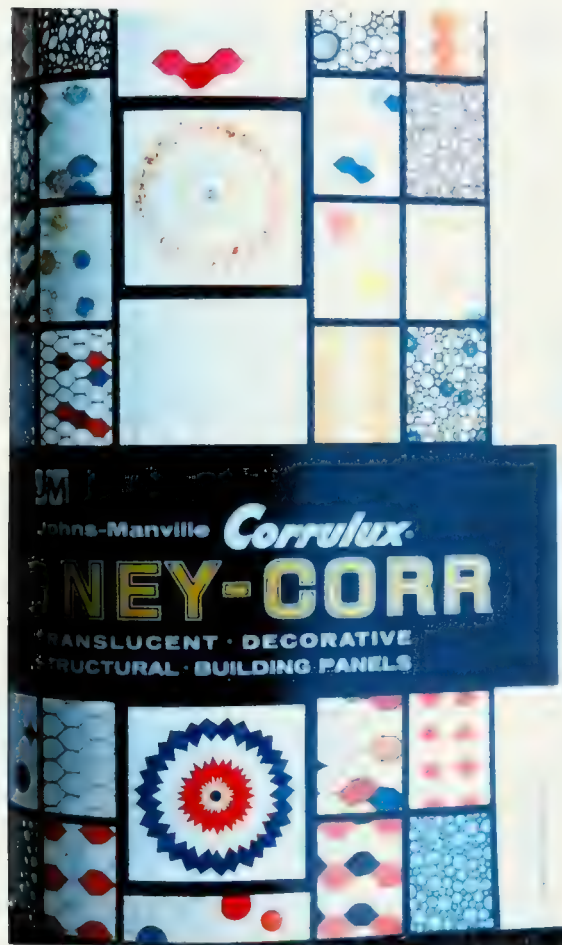
5-24

“Circa 1965 trade catalog front cover page of cellular core sandwiched by fiberglass reinforced acrylic panels manufactured by Johns-Manville”

**Description:** There is a shelf going across the entire width of the component, which made it unclear whether or not this light gold colored partition with elliptical cellular core was composed of one or two panels. Other similar fiberglass reinforced acrylic panels, Corrugulux Honey-Corr® made by Johns-Manville and Tropiglas® by Russell Reinforced Plastics Corporation, however, came in standard sizes that were three to four feet high. The former is the measurement of the panel at Dragon Rock. Thus, it appears that this is more than likely one panel.

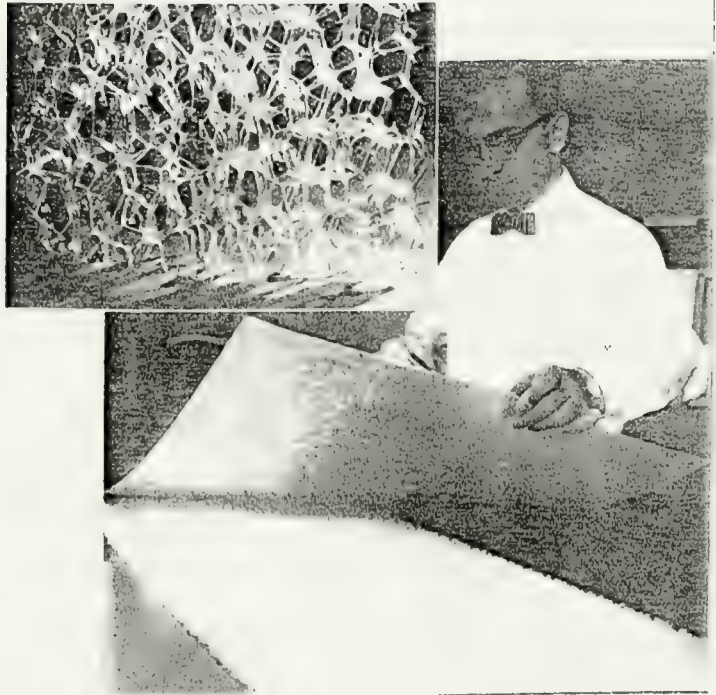
5-25

**LARGE CELL** rigid foam (right), actual size, is extruded in 1-in. thick panel from copolymer of styrene and methyl methacrylate. Insulating foam, sandwiched between 1/4-in. colored methacrylate, is used as glazing. At far right, methacrylate skin is adhered to foam.

“1962 article from *Modern Plastics* discussing the new styrene and acrylic rigid foam sandwiched by acrylic panels manufactured by the Dow Chemical Company”

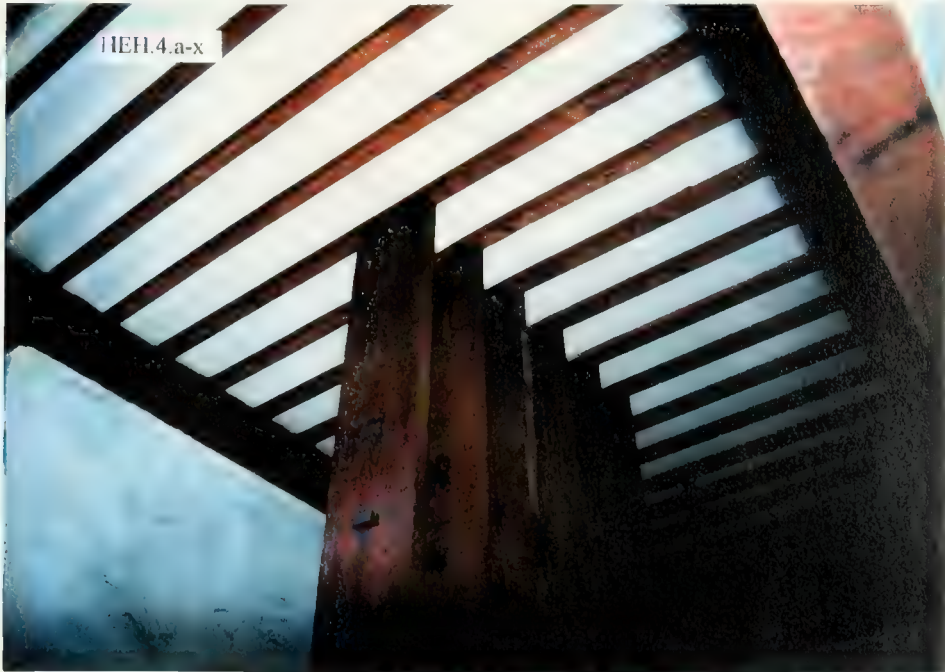
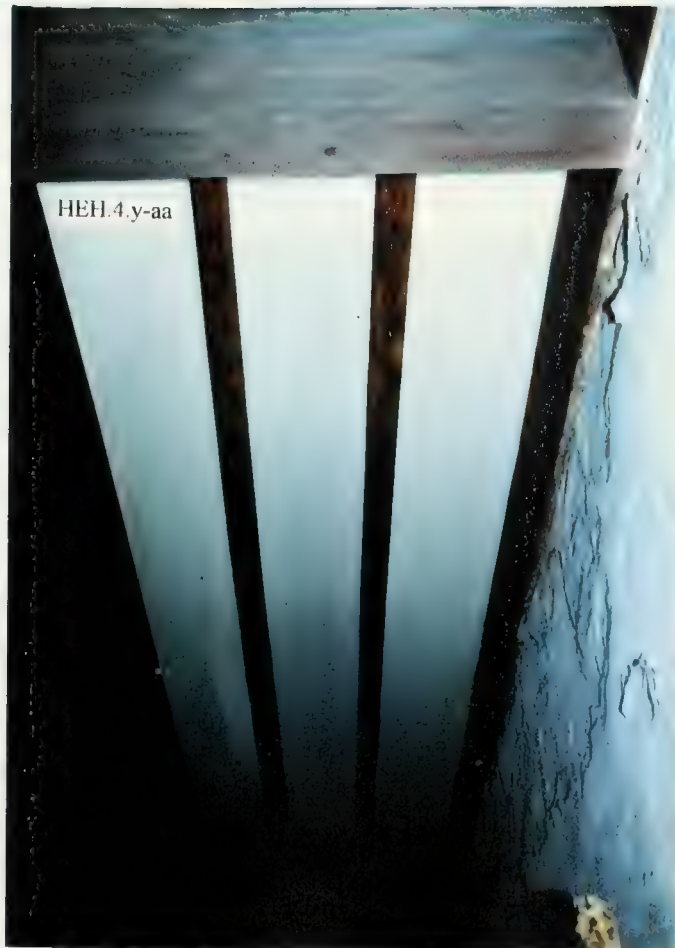
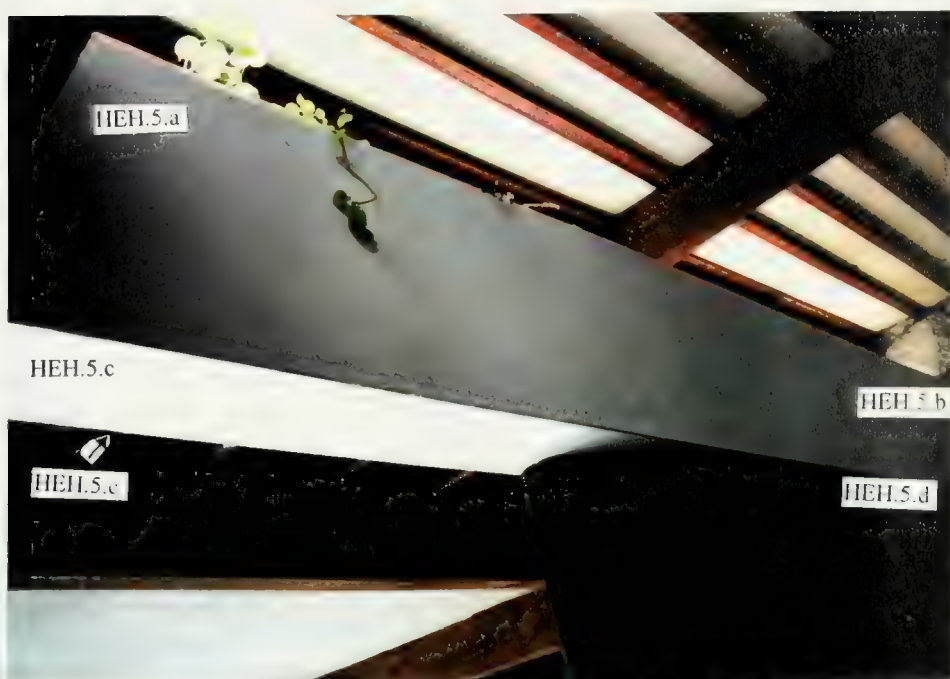
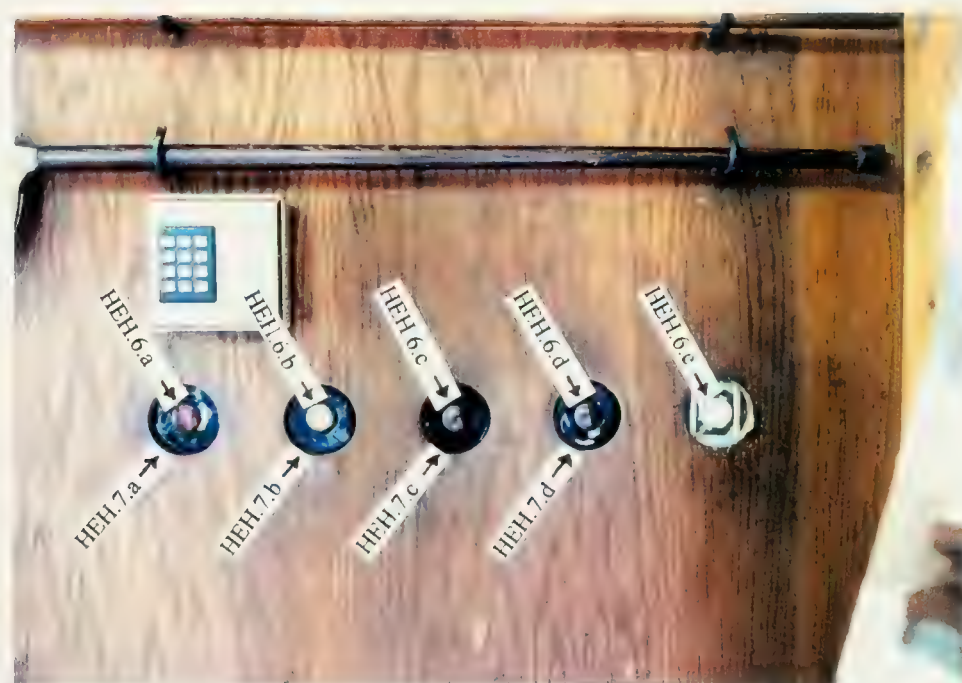
<b>Alterations:</b> No
<b>RESIN MANUFACTURER/PROCESSOR/FABRICATOR INFORMATION</b>
<b>Resin Trade Name:</b> (unknown)
<b>Resin Manufacturer:</b> (unknown)
<b>Processing Method:</b> (unknown)
<b>Processed Product Trade Name:</b> (unknown)
<b>Processor:</b> (unknown)
<b>Fabricator:</b> Minneapolis-Honeywell Regulator Company; Minneapolis, Minnesota
<b>CONDITION SURVEY</b>
<b>General Condition:</b> Good
<b>Description:</b> There is no sign of deterioration.
<b>Environmental Factors:</b> 1) <i>Natural light:</i> There is some sunlight from the southeast entry door.
<b>Maintenance and Conservation:</b> UV radiation from sunlight should be reduced from the entry door through the use of a UF3 acrylic panel. The component should be lightly dusted as needed.

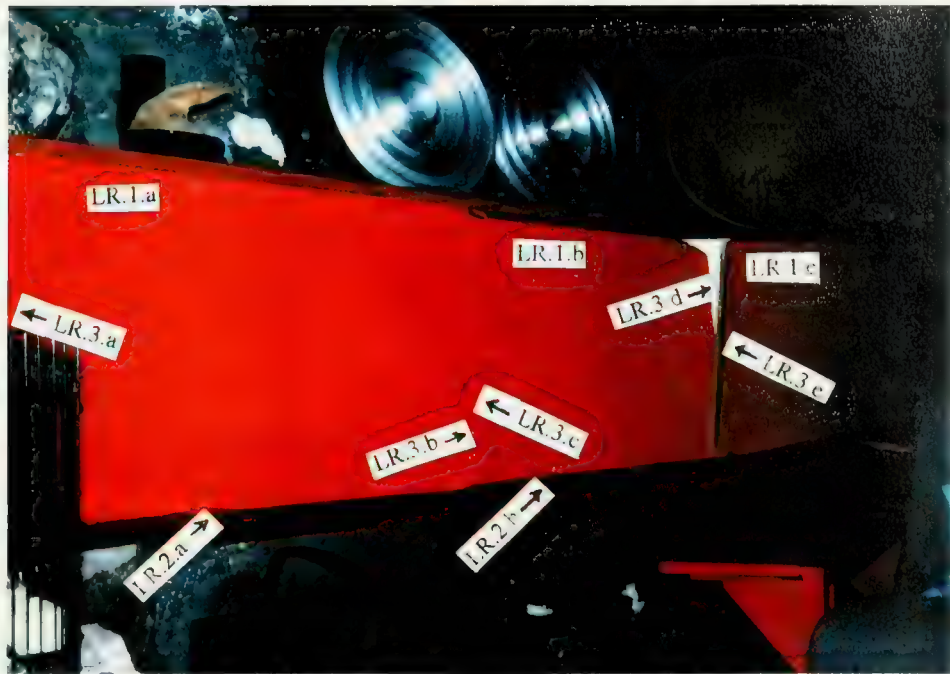
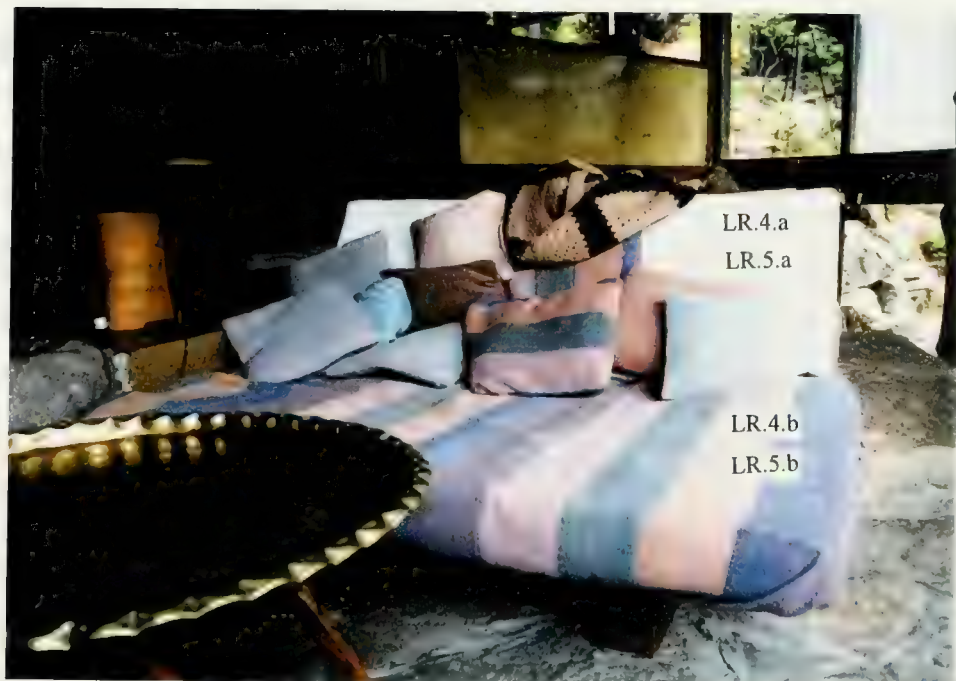
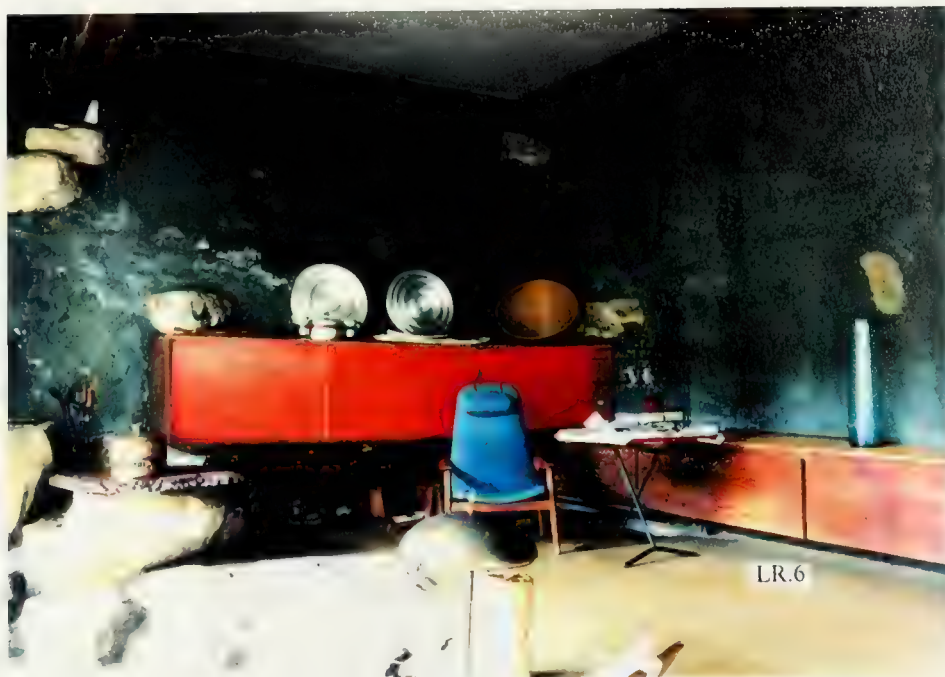
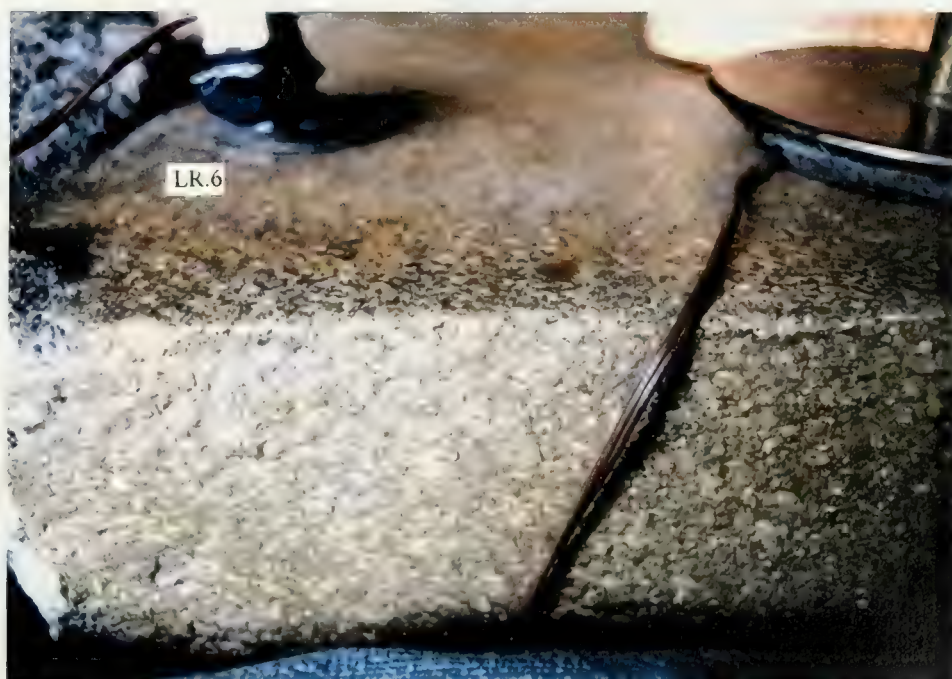
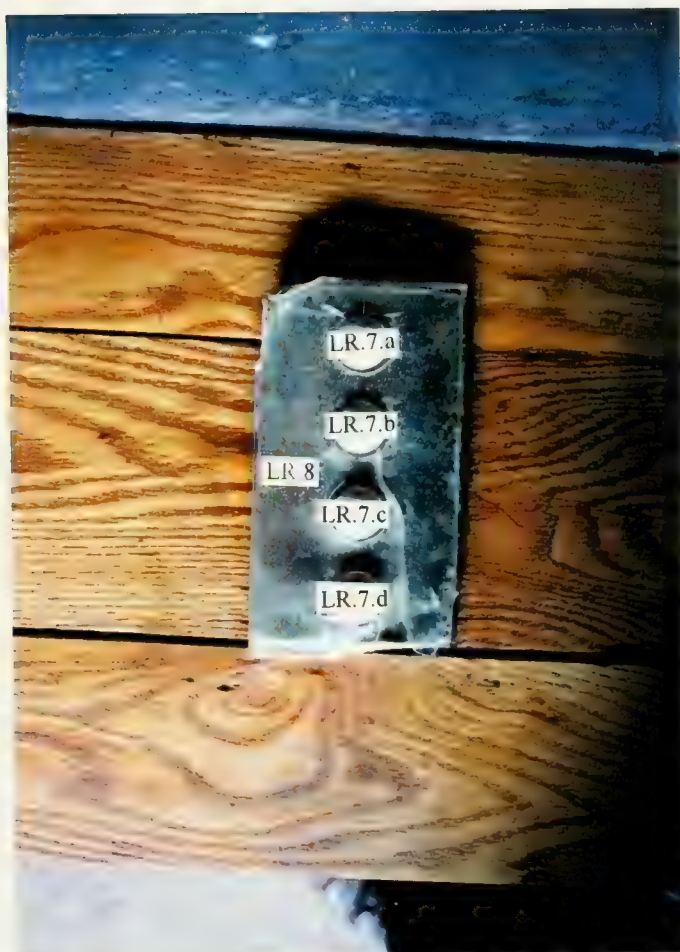
**General Condition:** Fair to poor  
**Description:** There are three sections of the component edge missing, and a cracking down the middle.  
**Environmental Factors:** 1) *Natural light:* All of the exterior wall spaces of the dining room is two stories of glass in wood frame. In the living room, the entire one story height is glass in wood frames. The component is in the direct path of the heat of the sunlight, which could be harmful. 2) *Artificial light:* There are no overhead lights, just one small lamp with two fluorescent light bulbs.  
**Maintenance and Conservation:** UF3 panels should be attached to the frames of the windows in order to filter UV radiation. For now, light dusting as needed. In order to repair this component, the plastic type needs to first be identified. Replacement may be a consideration after documenting and storing this original component.
